## Camp Edwards Small Arms Range Working Group Range Inspection Form J RANGE

Date of Inspection: \_\_\_\_\_ 06-14-11 \_\_\_\_\_

Organization: \_\_\_\_\_ U.S. EPA \_\_\_\_\_

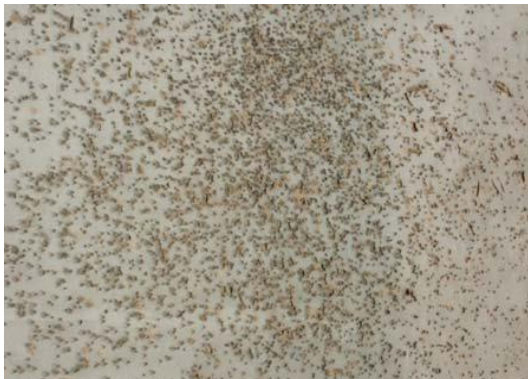
**GOOD condition:**

Some dimpling of surface, but no black rubber granular material is visible

*Look for any portion of the cover where the black rubber granular material is visible.  
Black rubber granular material is not visible. However, due to the accumulation rate of water in the STAPP reservoir replacement of the membrane should be considered.*

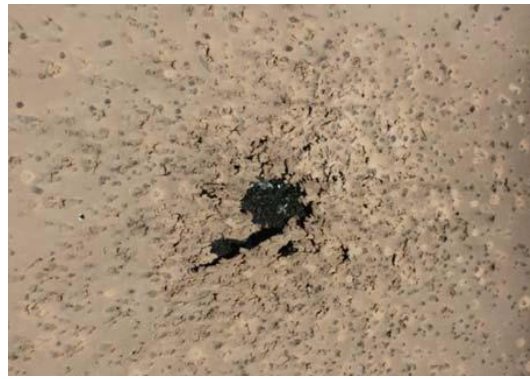
**POOR condition:**

Any holes in the surface where the black rubber granular material is visible

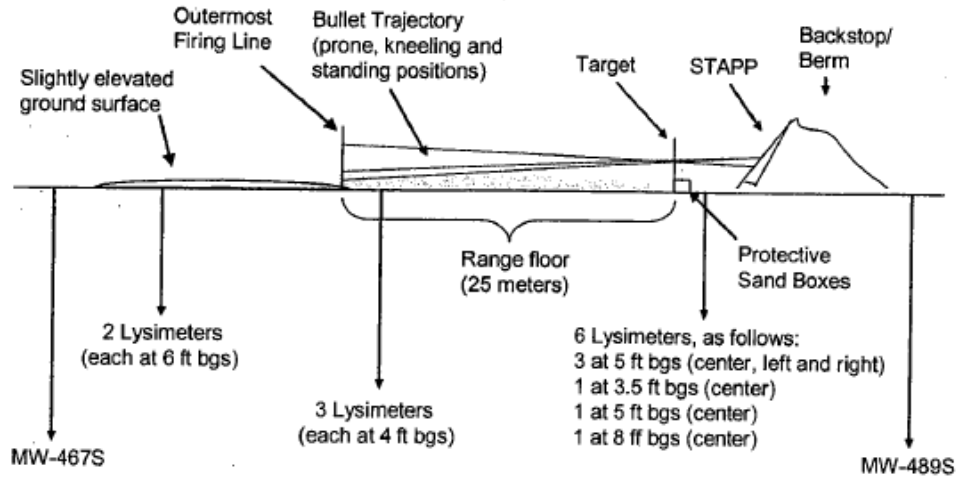
**Key:**

Multiple firing distances in range floor  
 maximum distance is 25 meters from target (Outmost firing line)  
 minimum distance is 3 yards from target
